České vysoké učení technické v Praze, Fakulta stavební

Doc. Ing. Michal Polák, CSc.

Experimentální analýza dynamického chování stavebních konstrukcí

Experimental Analysis of Dynamic Behaviour of Building Structures

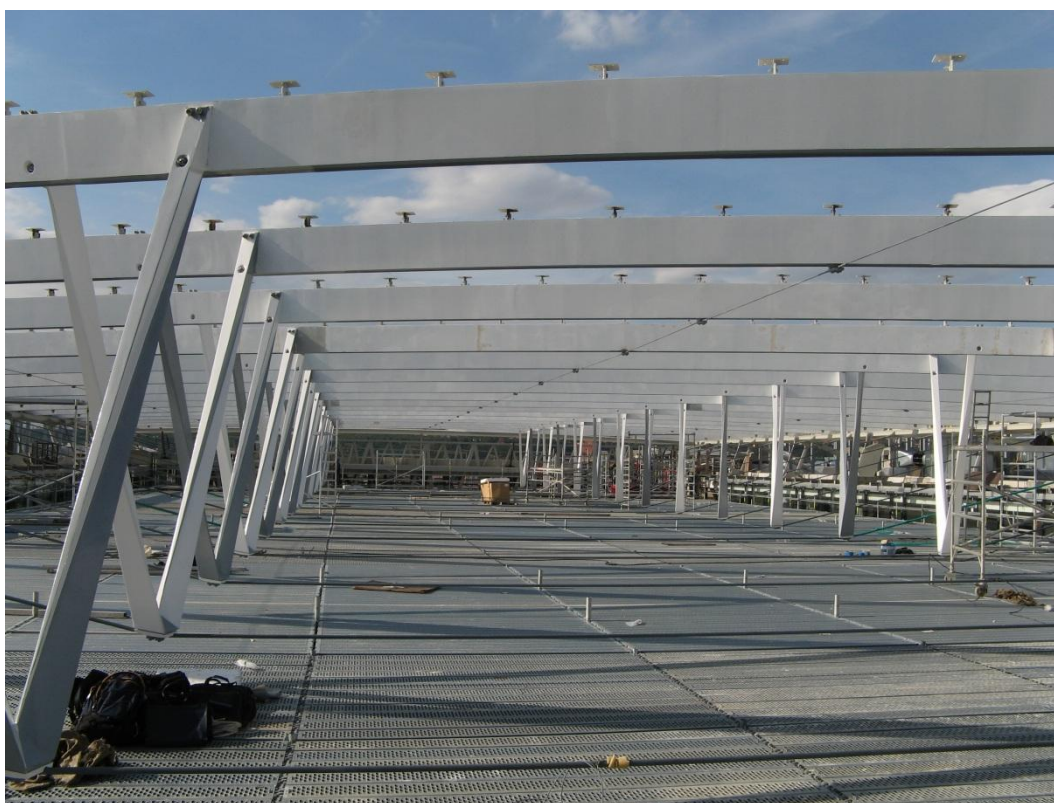
Figure 1: The view on the steel structure of the roof of Administrative Centre Amazon Court

The Administrative Centre Amazon Court is situated in Prague - Karlin. The atrium of this building is covered by a pneumatically controlled roof on a steel structure. V-shaped bracing struts are placed on the system of steel cables stretched across the atrium (Fig. 1). The roof is covered with belts of triple-layer ETFE foil, stretched between purlins and inflated. ETFE foil is transparent, not flammable, leakproof, and heat resistant up to 270°C.

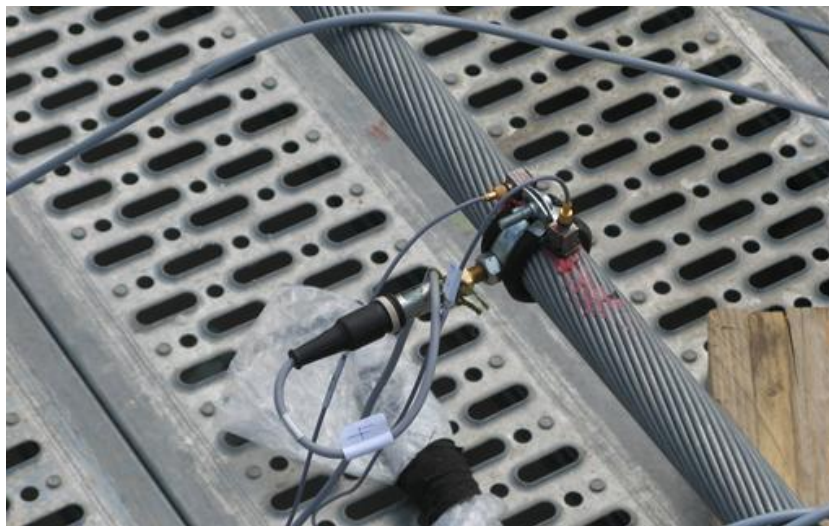
Figure 2: The view on the vibration transducers (accelerometers) installed on the cable.

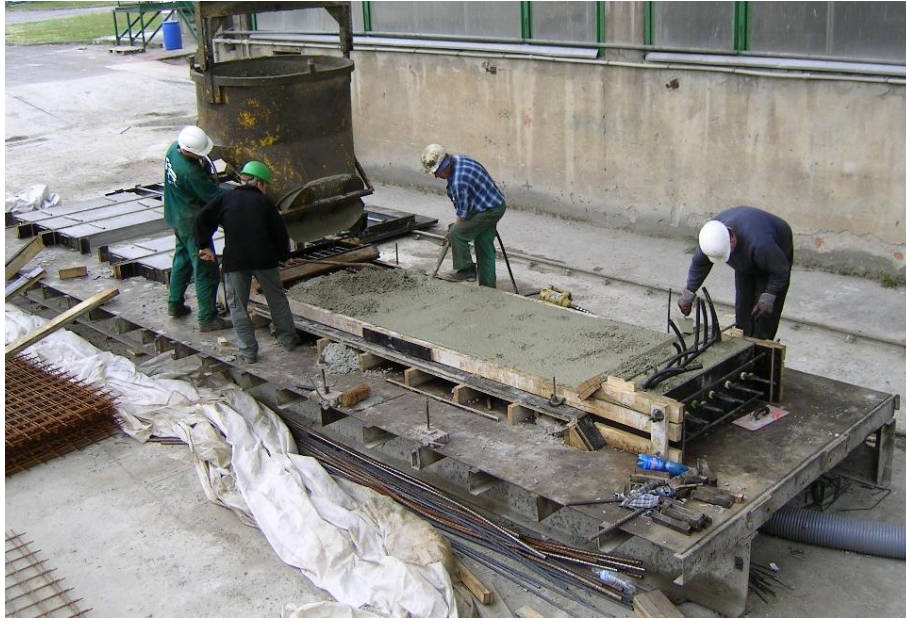
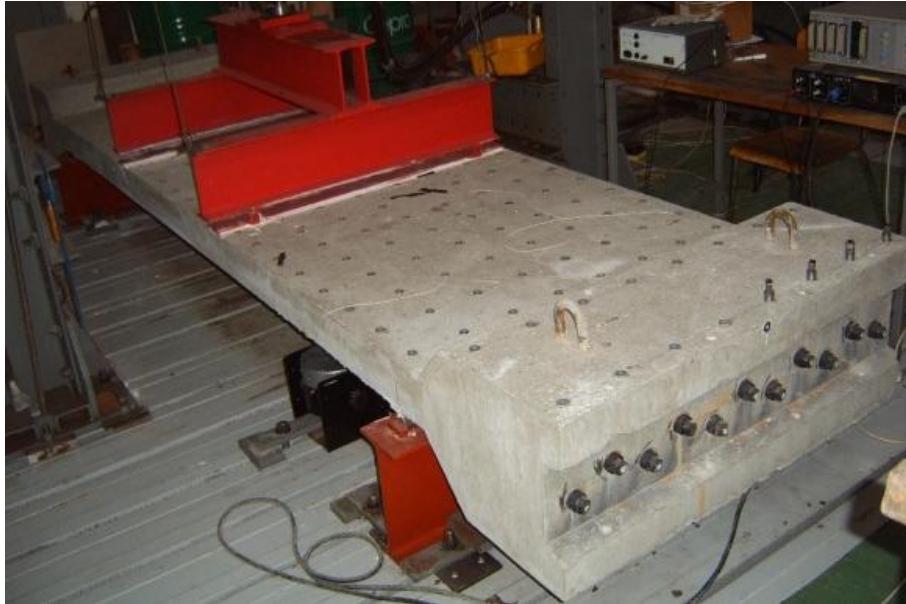
Figure 4: The view on the slabs concreting and the position of the slab in the loading stand.

The tested slabs were designed atypically compared to normally produced fully prestressed slabs. The centric prestressing was used to create great pressure reserve in the lower part of the slabs for application of high intensive cyclic loading.

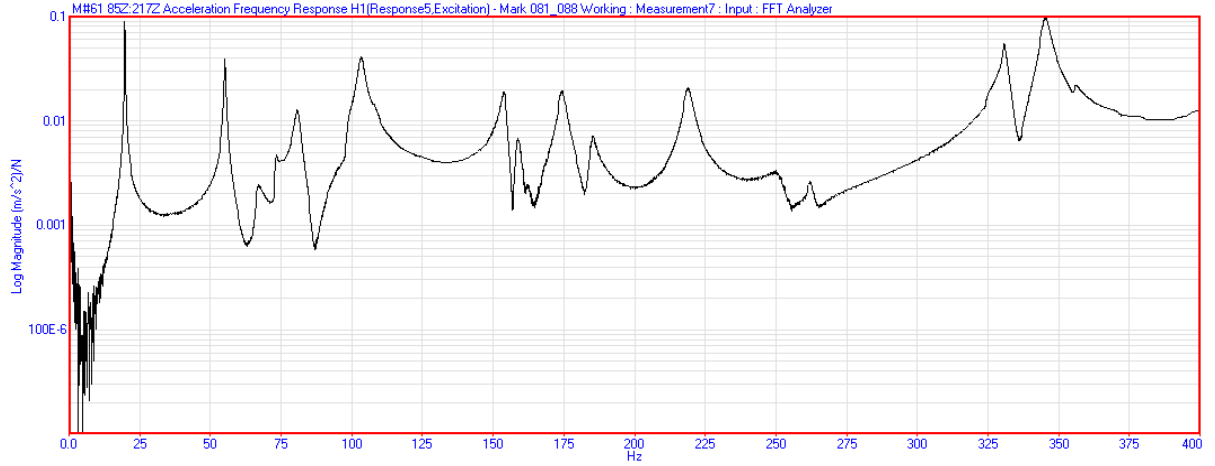
Figure 5: The example of the FRF in the point No.85 in the state of the slab No. 1 after 3 500 000 cycles.

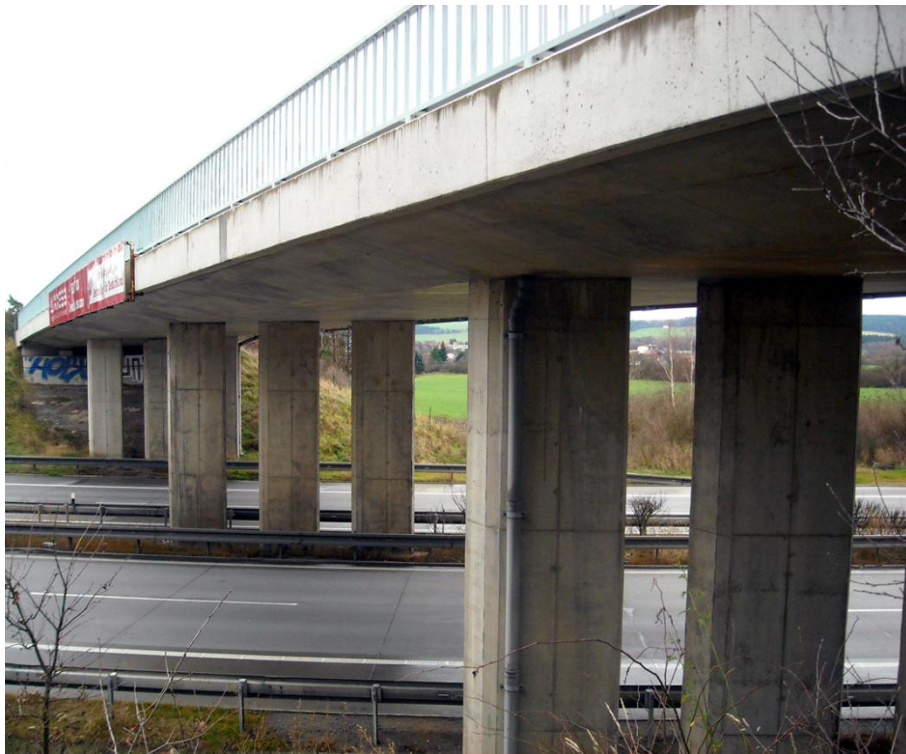
Figure 8: The view on the prestressed concrete slab bridge near the village Heřmanova Huť.

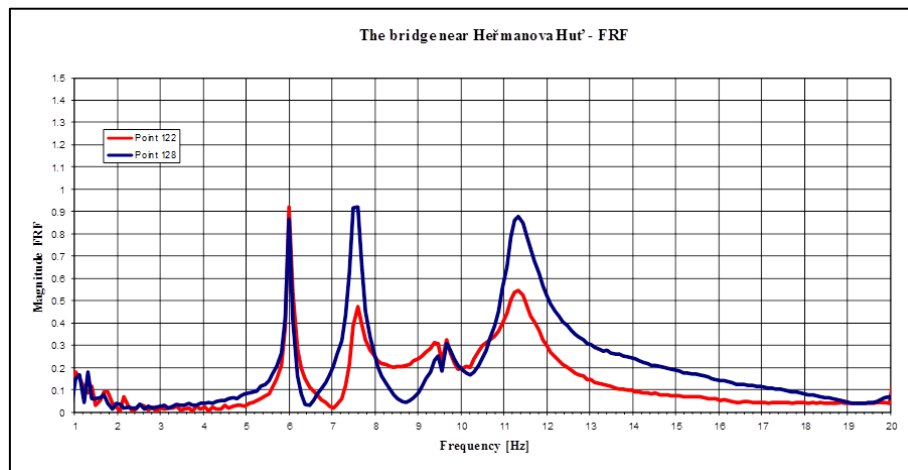
Figure 9: The example of two measured frequency response functions.

Experimental modal analysis (e.g. [2]) was carried out on this bridge. The electrodynamic shaker TIRAVIB 5140 was used for excitation of the bridge. The excitation force was measured by three force transducers S-35 LUKAS, which were interconnected to measure directly the whole driving force. The response of the bridge was measured by ten inductive accelerometers B12/200 HBM. Vibration control system 2550B Spectral Dynamics with control computer Sun was used for data acquisition and data analysis. The bridge was excited by random driving force of white type noise of the frequency range from 0 to 20 Hz. The driving force was controlled by signal generator SG 450 ONO SOKKI.

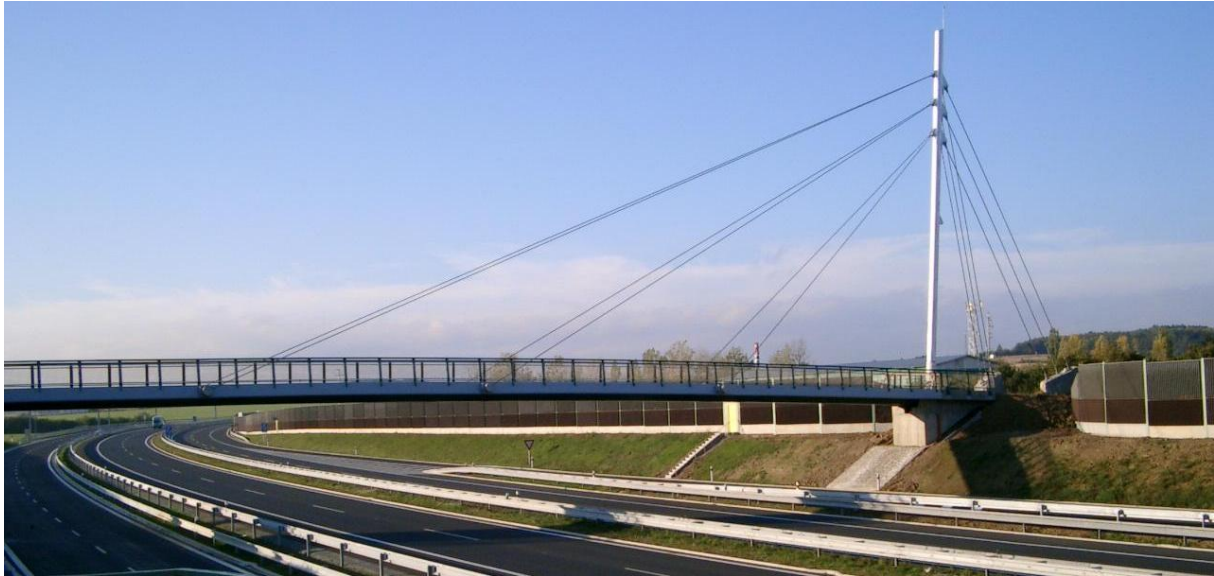
Figure 13: The footbridge overview.

The structural system of the footbridge consists of a single span steel box girder with two planes of cables and an external steel pylon (Fig. 13). The box girder is lifted by three pairs of front stays. The pylon is anchored by three pairs of back stays to the massive concrete fundament.

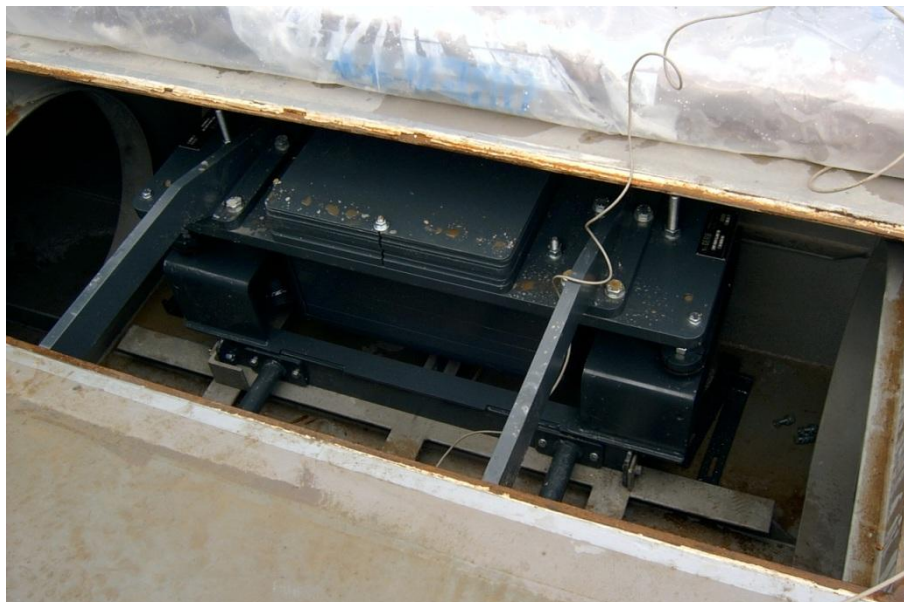
Figure 18: The installed absorber (TMD) inside of the box girder.

The pedestrian comfort limits were not exceeded for the groups of pedestrians, which simulated a normal operation on the footbridge. Nevertheless, an idea of using a TMD has been considered to reduce the vibration mainly at the lower natural frequency $f_{(1)} = 1.55$ Hz due to the very high dynamic sensitivity of the footbridge to vibration at this frequency caused by vandalism (Fig. 17 above), in which the measured acceleration peak value exceeded gravitational acceleration, the evaluated peak value of vertical displacement was 10 cm.

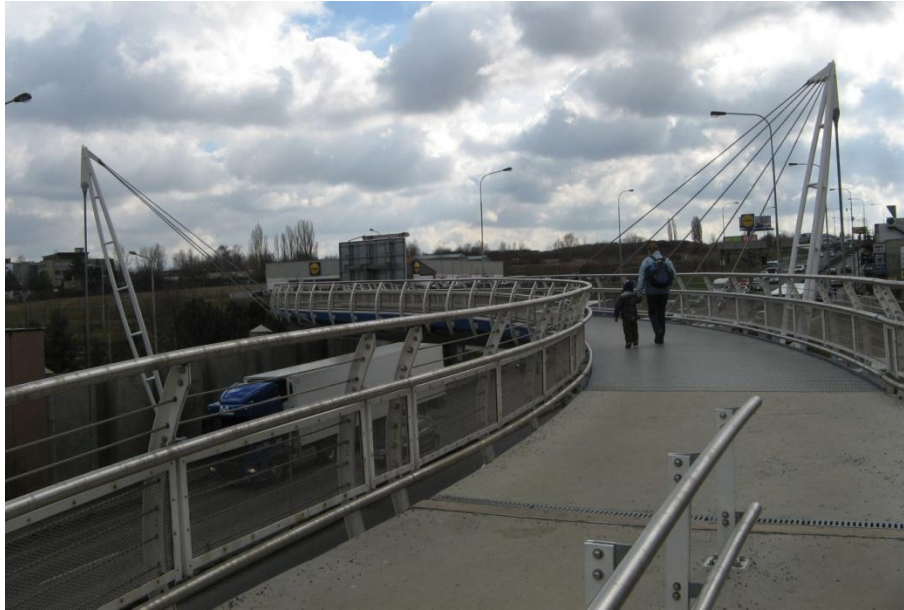
Figure 19: The footbridge overview.

The footbridge in Prague – Barrandov (Fig. 19) was put into operation 1.6. 2006. This footbridge connects two urban areas, divided by the frequented highway “K Barrandovu”. The footbridge is formed by the tube main girder with the truss bridge deck, which is suspended to two skew pylons. Two tuned mass dampers (TMDs) are used to ensure comfort for pedestrians.

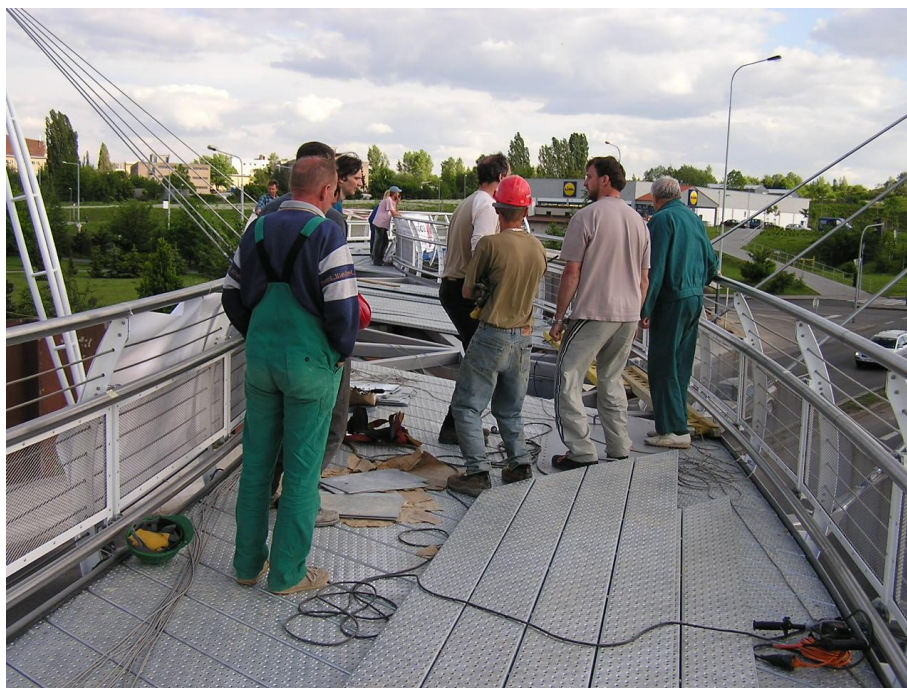
Figure 20: The group of vandals on the footbridge deck.

- The dynamic response of the observed footbridge to the extreme effects of a group of vandals (Fig. 20) was measured.
- The tuning of the installed TMDs was assessed. The modification of the masses was proposed to optimize their ability to reduce vibration of the footbridge on the basis of the differences between the measured and calculated natural frequencies, for which the TMDs were tuned. For the first TMD tuned to a lower natural frequency was proposed the mass modification to 751 kg and for the second TMD to 814 kg.

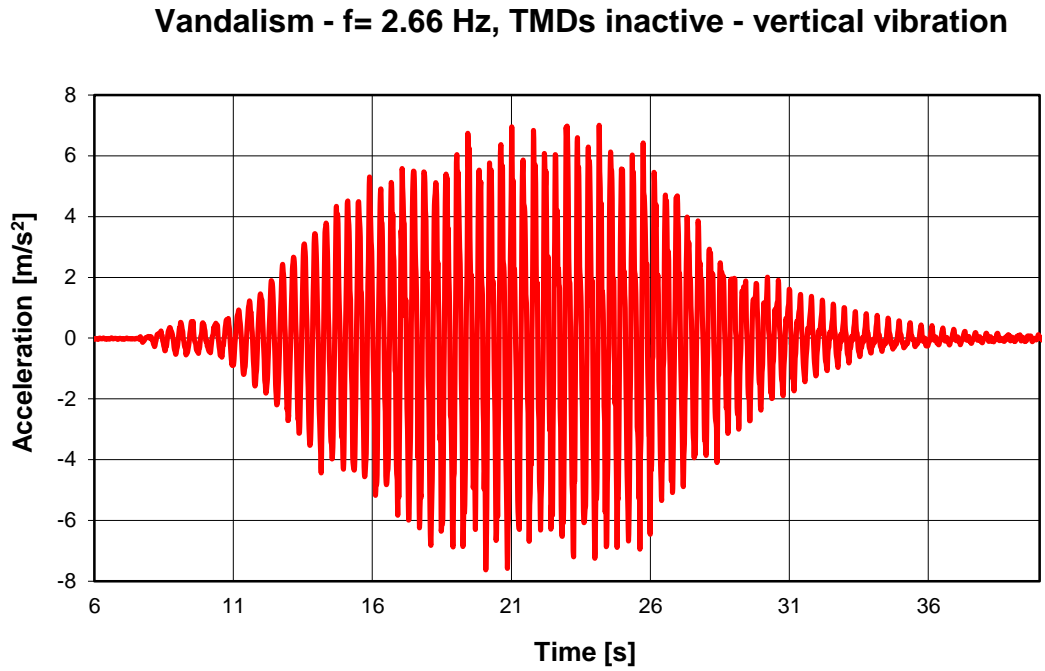
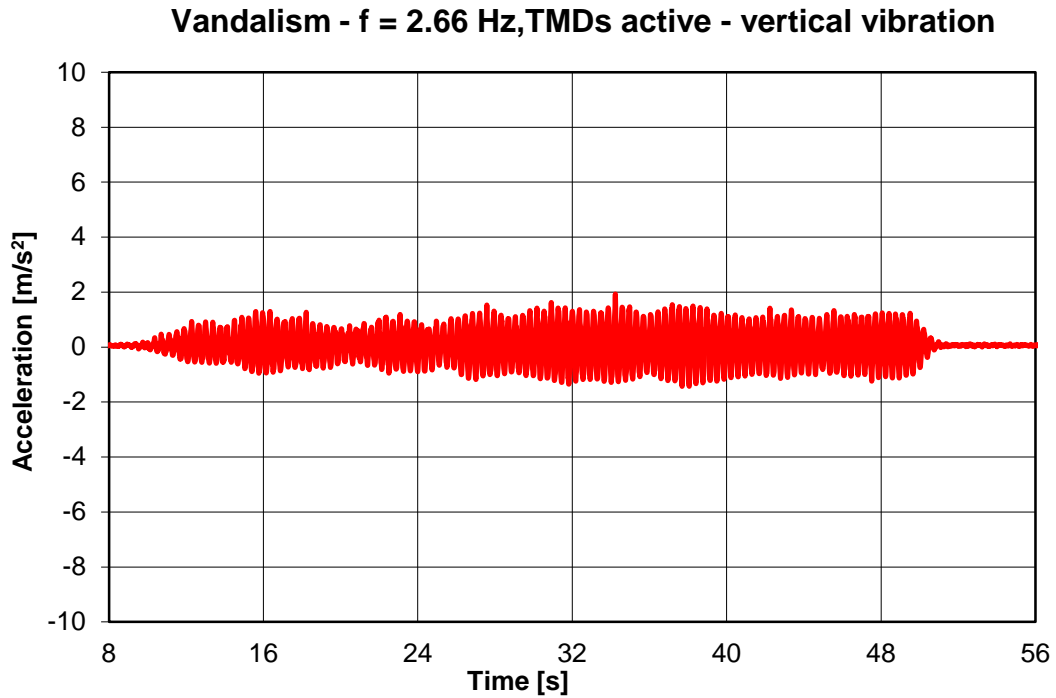
Figure 21: The dynamic vertical response of the footbridge deck to the vandalism with the inactive TMDs (above) and with the active TMDs (below).

- The efficiency of the TMDs caused by the pedestrians was verified based on the dynamic response of the footbridge to the extreme effects caused by the group of vandals (Fig. 21).

The ability of the passive dynamic dampers, which are installed on the investigated footbridge, for significant reduction of the level of the footbridge vibration was demonstrated on the response caused by group of vandals. As shown in Fig. 21, the dynamic response of the footbridge significantly decreased after activation of TMDs to one seventh.

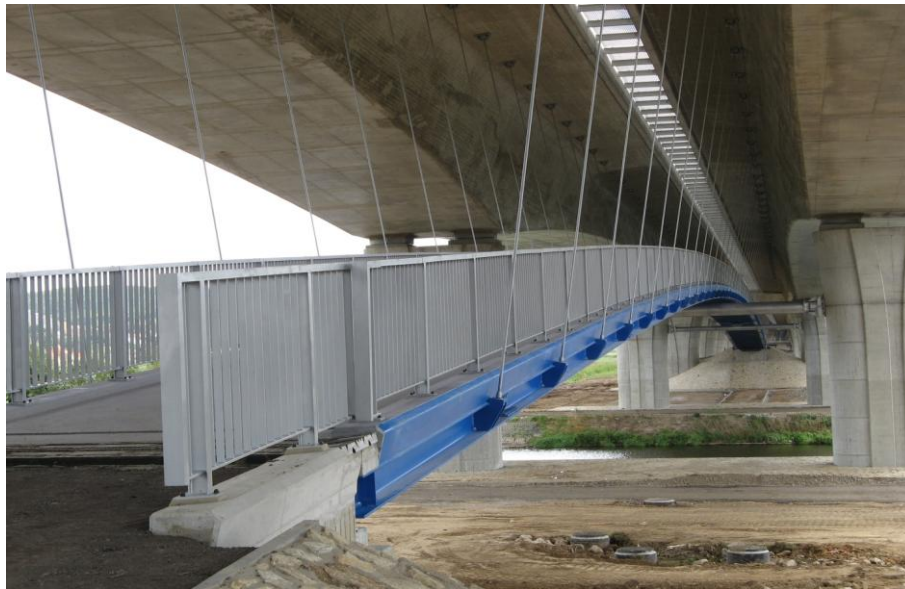
Figure 22: The footbridge overview.

The footbridge across the Berounka river in Prague - Radotín (Fig. 22) was put in operation in October 2010. The load bearing structure of the footbridge is suspended to cantilevers of two box girder prestressed concrete bridges that are parts of the Prague Ring Road (SOKP 514). The footbridge suspenders are made out of steel rods with a diameter of 26 mm. The distance of cross sections with suspenders is 4.0 m. The horizontal load bearing structure is the steel and concrete composite structure. The cross section consists of two main steel girders HE300B and transverse beams HE300A. The girders are coupled with a reinforced concrete slab with the thickness of 200 mm. The footbridge has three spans of lengths 48 m, 84 m and 48 m. The horizontal alignment of the footbridge is straight line. The vertical alignment of the footbridge is parabolic vertical curve with the rise of 3.75 m in the centre of the footbridge.

A special feature of this footbridge is that the structure supporting is flexible in the longitudinal axis. The bearing, which does not allow movement of the footbridge in the horizontal longitudinal direction, is placed on the transverse beam. This beam is placed between the spans number 1 and 2 and it is fixed on the pillars of road bridges. The expansion joints on the both abutments are covered with elastomeric seals.

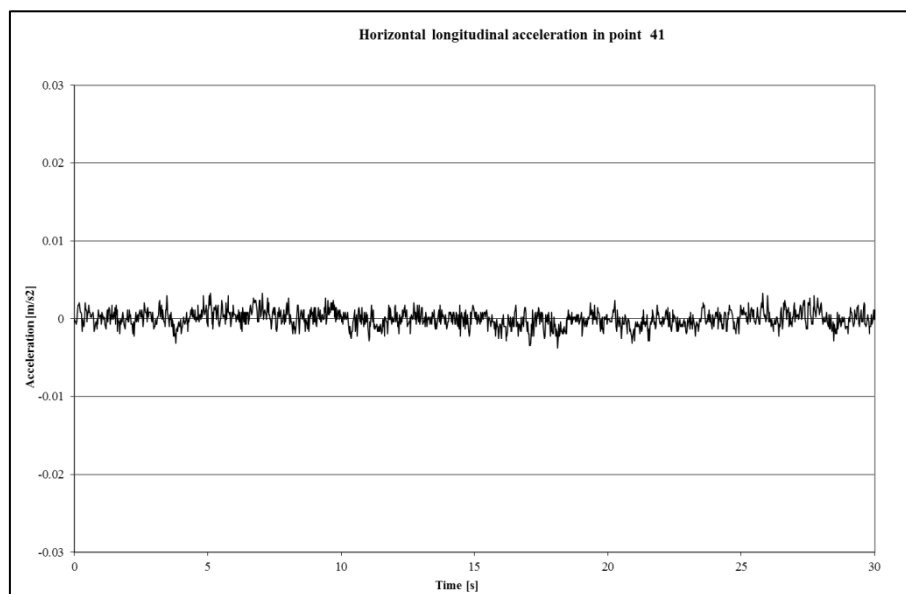
Figure 23: The dynamic horizontal response of the footbridge deck to the full braking of one cyclist.

The sudden stop of sprinting runners excited especially the vertical vibration of the footbridge deck. As shown in Fig. 23 and 24, the horizontal longitudinal vibration of the footbridge deck caused by the above mentioned two groups of users is small. The pedestrian comfort limit was satisfied. The installation of hydraulic dampers was not necessary.

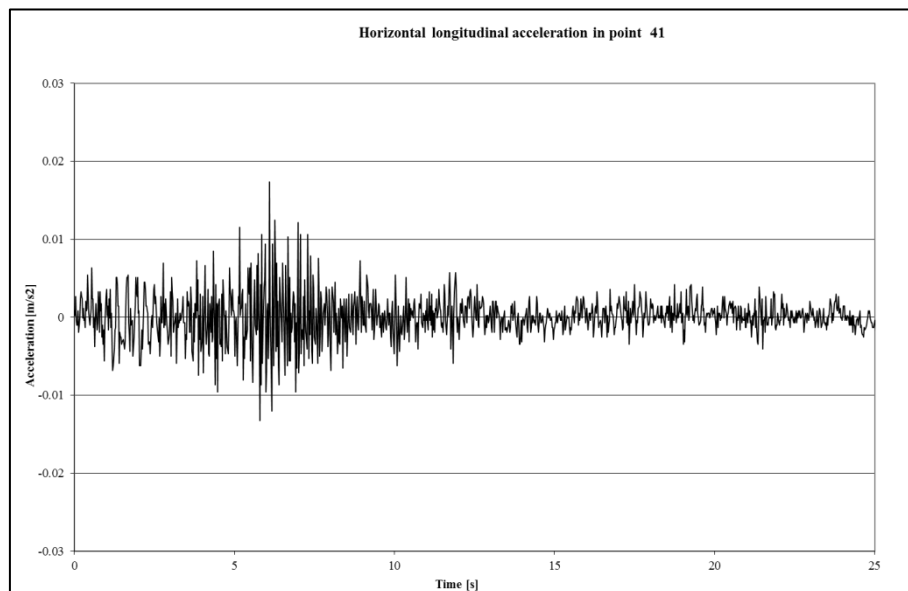
Figure 24: The dynamic horizontal response of the footbridge deck to the sudden stop of five sprinting runners.

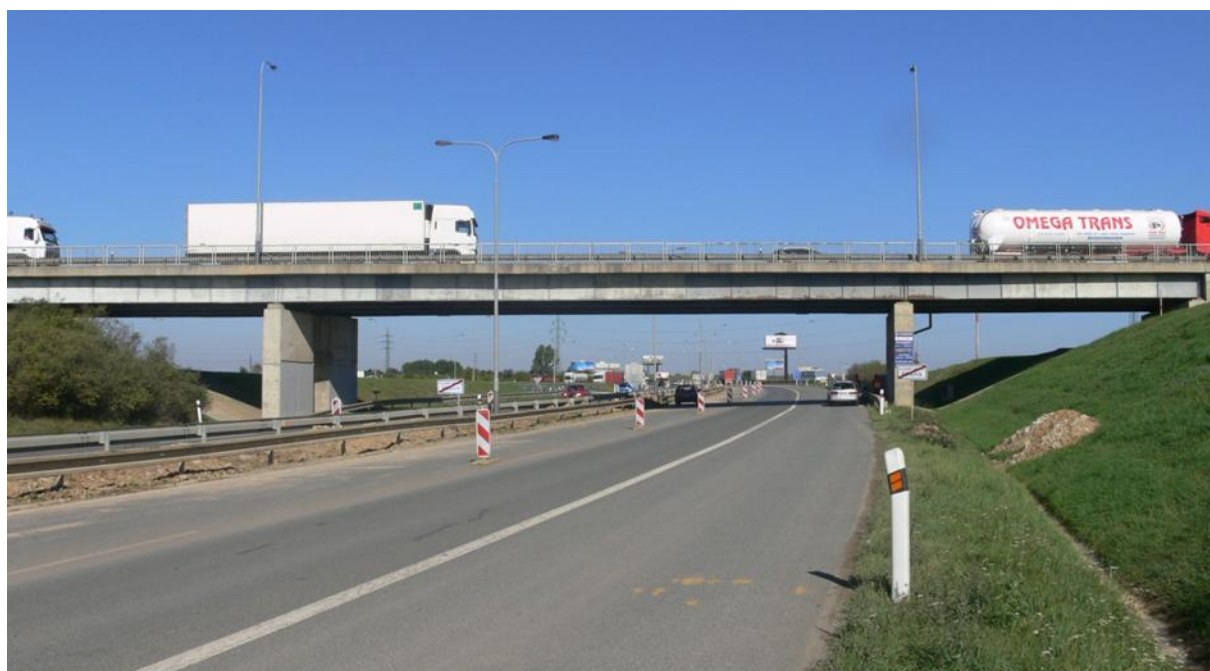
Figure 25: The view on the investigated bridge

Only the results of long-time monitoring of the slab-on-girder bridge response caused by heavy duty traffic are presented below. The investigated bridge (Fig. 25) is the three span continuous slab-on-girder bridge, which is situated across the four lane Prague Ring Road. The slip lane, which is changing into two lane road on the bridge leads to the street „K Barrandovu“ in Prague. Before opening new part of the Prague Ring Road in September 2010, the heavy duty traffic goes in the south lane of the bridge in the direction Plzeň D5 – Prague Ring Road – Brno D1.

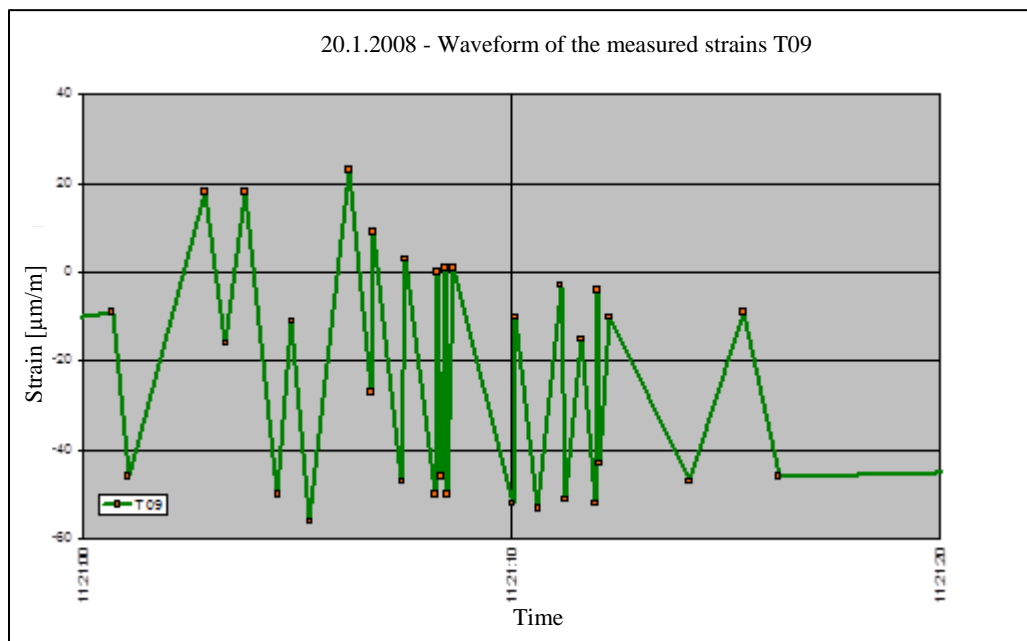
Figure 27: The dynamic response of the investigated bridge caused by two heavy trucks (Fig. 26).

The advantage of the used measurement line is that the control software of the dynamic measurement station EMS DV 803 enables continuous response measurement of the investigated bridge because the station does not need permanent connection to the computer. When the station is connected to the power supply and set properly, it can work with its inner memory (Compact Flash 512 MB) continuously and separately 5 months. The station records the values in two modes. In the basic mode the values of the response is recorded with period 30s. On the background the station measures the dynamic response continuously with the sampling frequency 50Hz. If the investigated structure vibrates significantly or the response reaches the level set in the control program, the station switches to the second mode and starts to record only peaks of the dynamic response, for which is the magnitude higher than the limit value. If the vibration is subsiding, the station switches back to the basic mode. The character of the response record composed of the values recorded in both modes is shown in the Fig. 27 and 28.

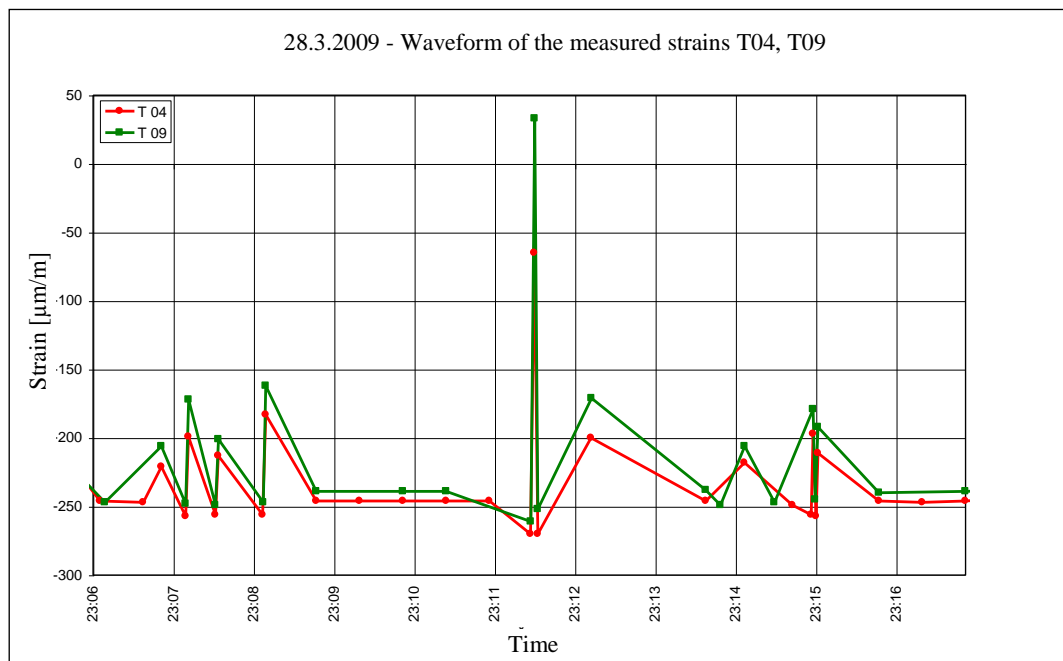
Figure 29: The substantial loading of the bridge structure, the measured extreme strain cycle on the figure is $294 \mu\text{m/m}$, which corresponds to the stress 62 MPa – the equivalent weight of heavy truck is 123 t.

The largest bridge response caused by a very heavy truck during the whole experiment was detected 28.3.2009 23:11:20 (Fig. 29). The equivalent weight of the truck was 123 t, it was an extraordinary transportation of heavy load. During the experiment in the years 2008 and 2009 the significant response of the bridge caused by trucks of the equivalent weight 90 t was measured about forty times and five times it was the response caused by trucks of the equivalent weight more than 100 t.

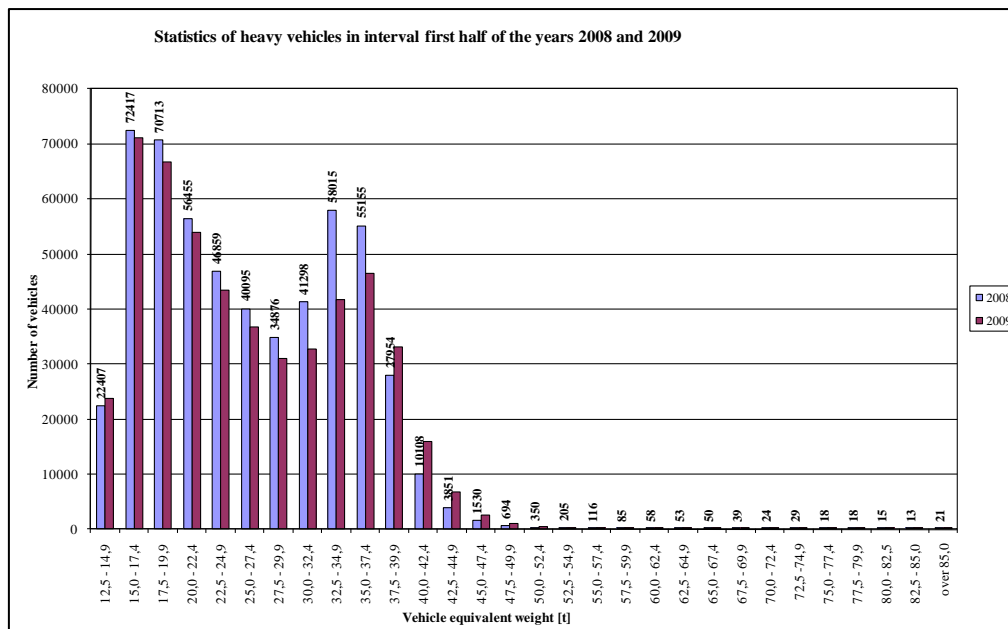
Figure 31: Statistics of the moving load of the bridge – comparison of the number of heavy vehicles for the first half of the years 2008 and 2009 (the total number of the heavy trucks 543 963 (2008) and 509 200 (2009)).
